Lower Colorado River Multi-Species Conservation Program

Beal Lake Conservation Area

2017 Annual Report

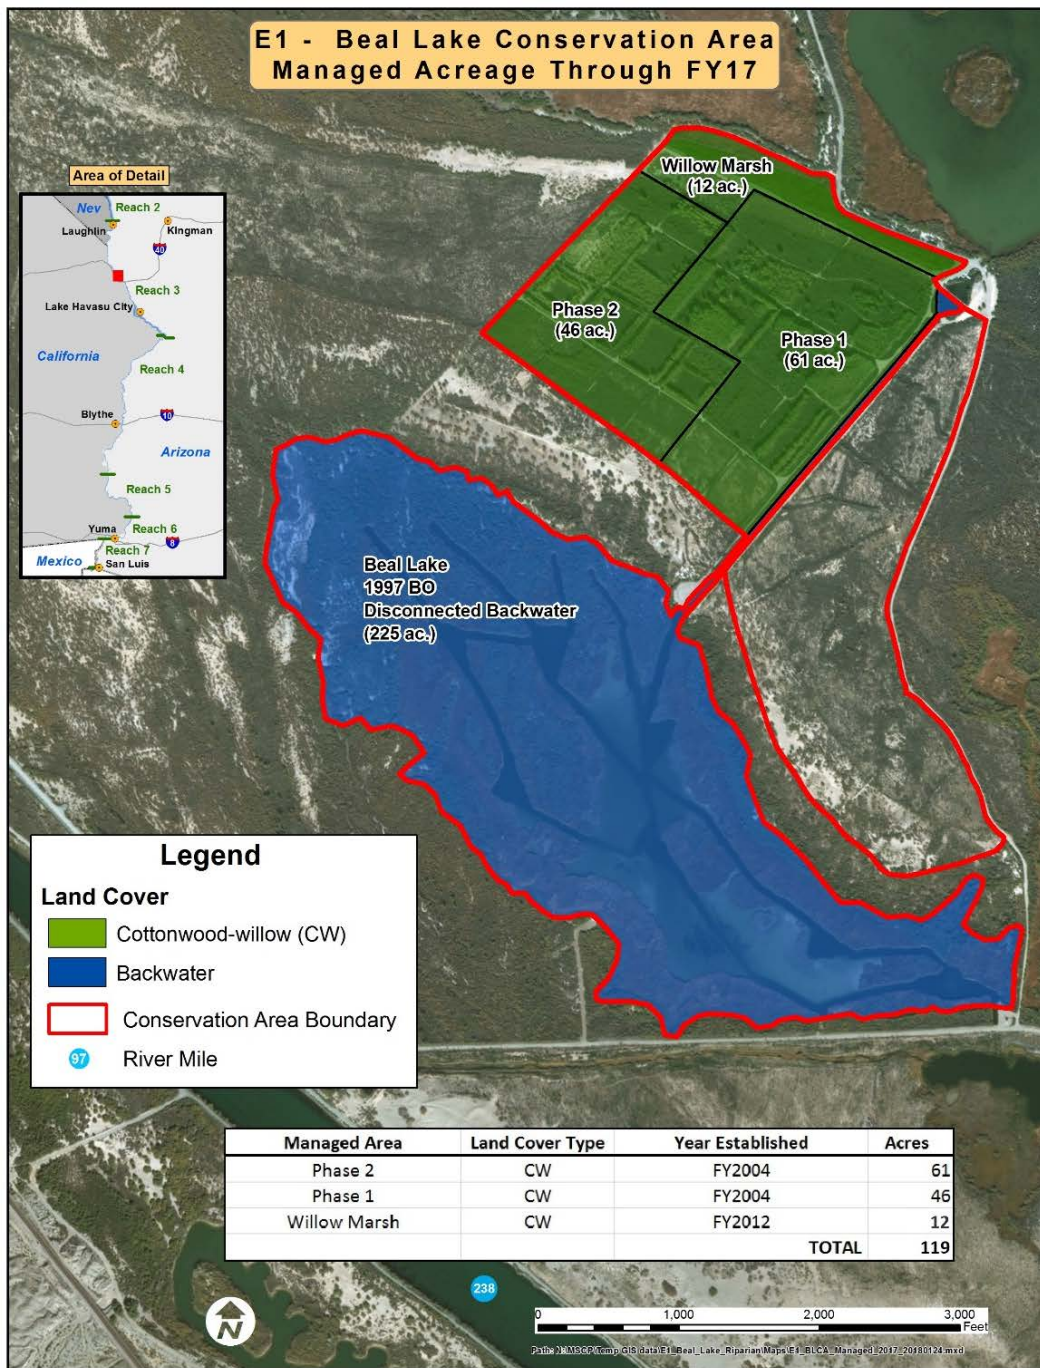
Figure 2.—BLCA managed acreage through FY17.

Figure 2 shows the established land cover types that are being managed for LCR MSCP covered species.

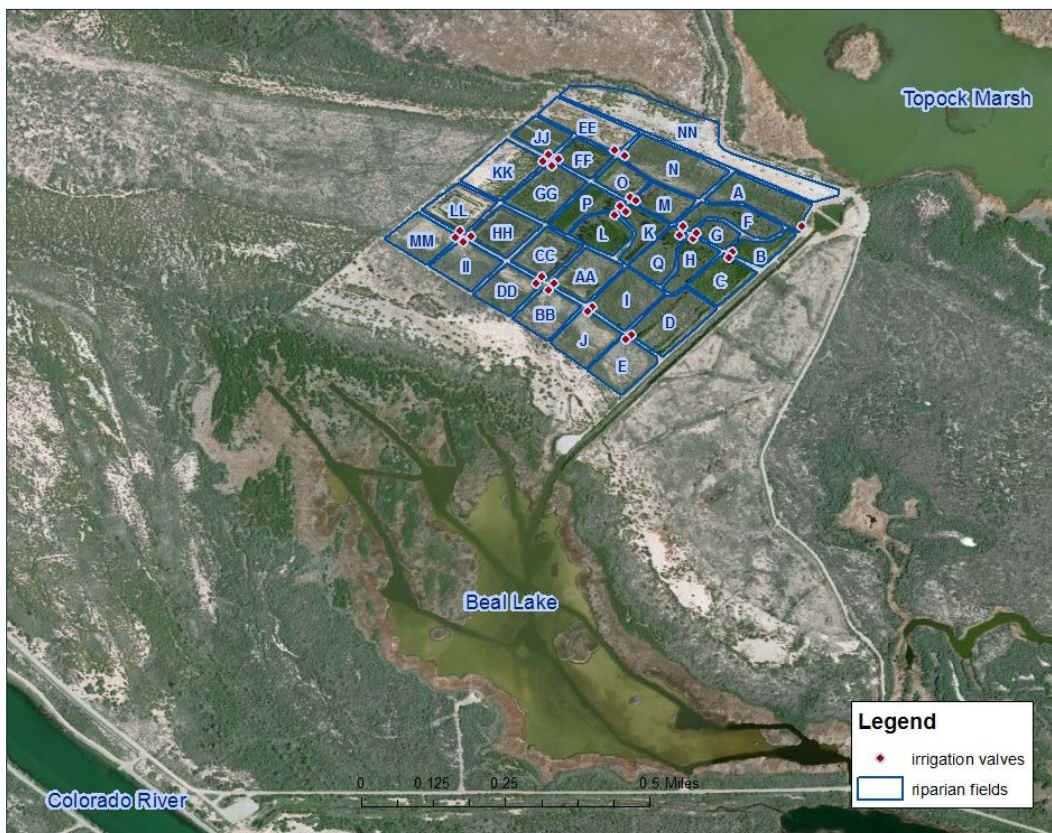
Figure 3.—Overview of the BLCA.

The fields at the BLCA are independently flood irrigated from one alfalfa valve positioned in a corner of each field (figure 3). The fields are irrigated on a schedule that prioritizes establishing newly planted vegetation when applicable, creating microclimate conditions for LCR MSCP species, and preventing salts from accumulating in the soil. The fields recently planted or seeded with native vegetation are irrigated on a weekly basis, while fields with established stands of trees are either frequently irrigated to create microclimate conditions for covered species or are put on a reduced irrigation schedule to merely keep salts from accumulating in the soil.

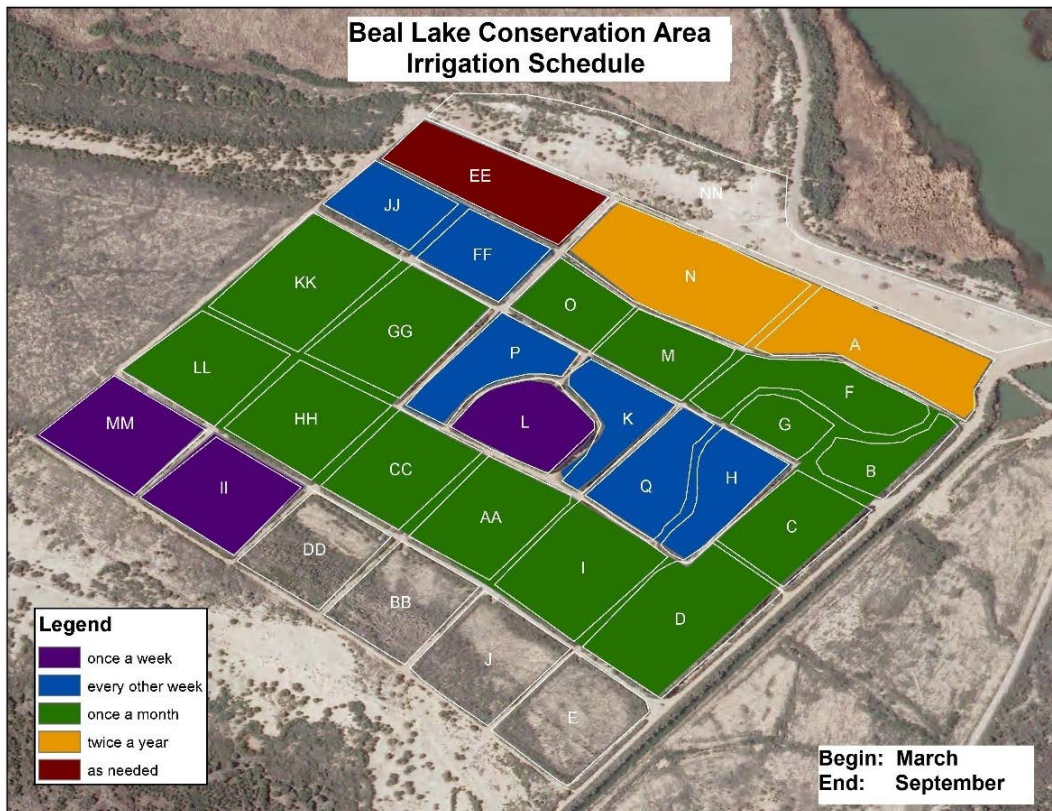
Figure 4.—FY17 irrigation schedule for the BLCA.

An irrigation schedule (figure 4) is prepared prior to each growing season. As the growing season progresses, small changes are made to benefit resource conservation. Rain, temperature, humidity level, groundwater elevation, etc., factor into weekly irrigation management.

During the 2017 irrigation season, 1,101 acre-feet of water was applied to the BLCA riparian fields compared to 1,132 acre-feet applied in 2016. The decrease in irrigation water was due to Cell EE requiring water on an as-needed basis. In FY16, the decision was made to irrigate Cell EE more regularly because of the dry appearance of the soil and yellowing of the trees; however, it was determined that less water resulted in healthier habitat.

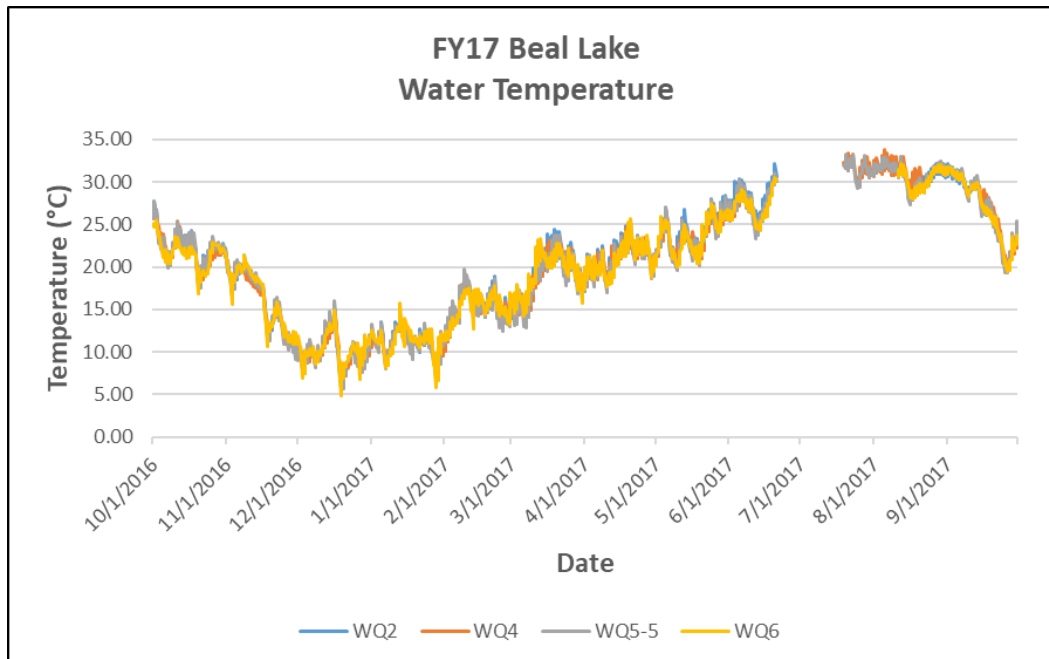
Figure 5.—Beal Lake water temperature, FY17.

Daily and annual cycling of water quality parameters in the lake were documented throughout FY17 (figures 5–8). Water quality data were scheduled to record continuously; however, a notable gap in data recording occurred in late June and early July due to battery failure. All water quality parameters were observed to be within expected seasonal and annual ranges throughout the year.

Four permanent sampling stations (WQ 2, 4, 5-5, and 6) have been equipped with multi-parameter water quality probes since May 2010. These stations are positioned throughout the lake, and their associated probes are deployed at a depth of approximately 1 meter below the water surface. The multi-parameter probes are programmed to record water temperature in degrees Celsius (°C), dissolved oxygen in milligrams per liter (mg/L), conductivity in microsiemens per centimeter (µS/cm), and pH twice each day. The measurements are recorded at 12-hour intervals, with the first reading occurring within 1 hour of sunrise and the second in late afternoon; this timing allows for daily minimums and maximums for temperature and dissolved oxygen to be recorded. The start times for the first recording of the day are adjusted monthly to account for seasonal shifts in sunrise. Water quality parameters within the lake have rarely exceeded the known thresholds for native fishes.
